# Navajo Abandoned Uranium Mine

## Site Screen Report

**Mine Name: Harvey Begay No. 1**  
**Mine ID: 375**

**August 2011**

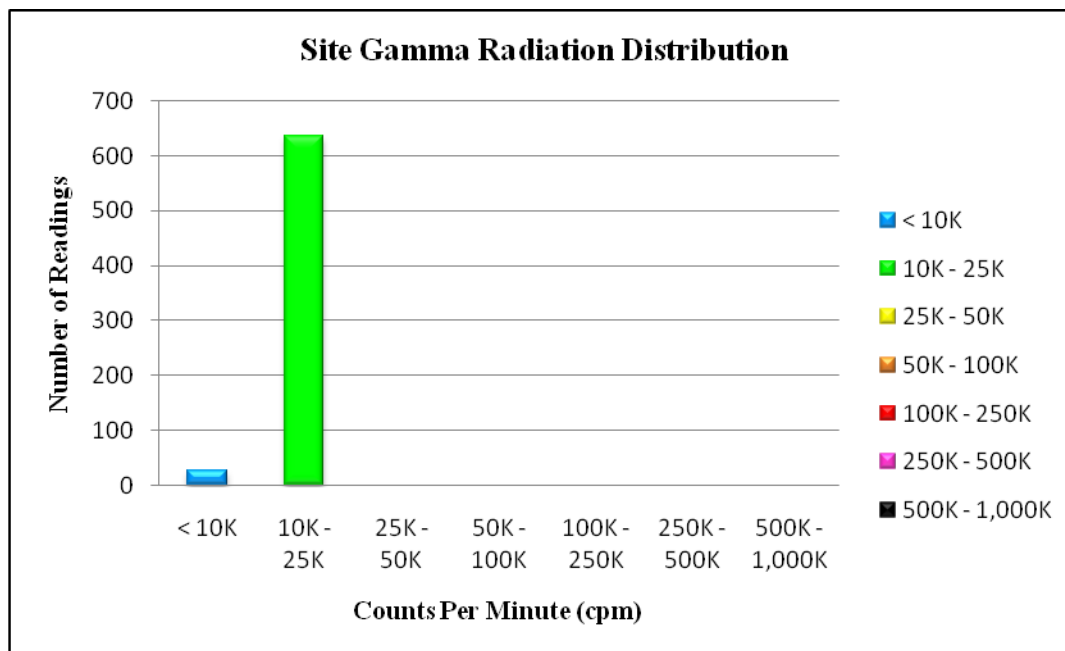
### Distribution Chart and Statistics:

A total of 664 gamma radiation measurements were collected from the mine site, ranging from 5,970 cpm to 21,224 cpm. The measurements are represented in Figures 1 and 2.

Site Gamma Radiation Statistics	
Number of Readings	664
Minimum (cpm)	5970
Maximum (cpm)	21244
Mean (cpm)	14930
Median (cpm)	15030
Standard Deviation	1930

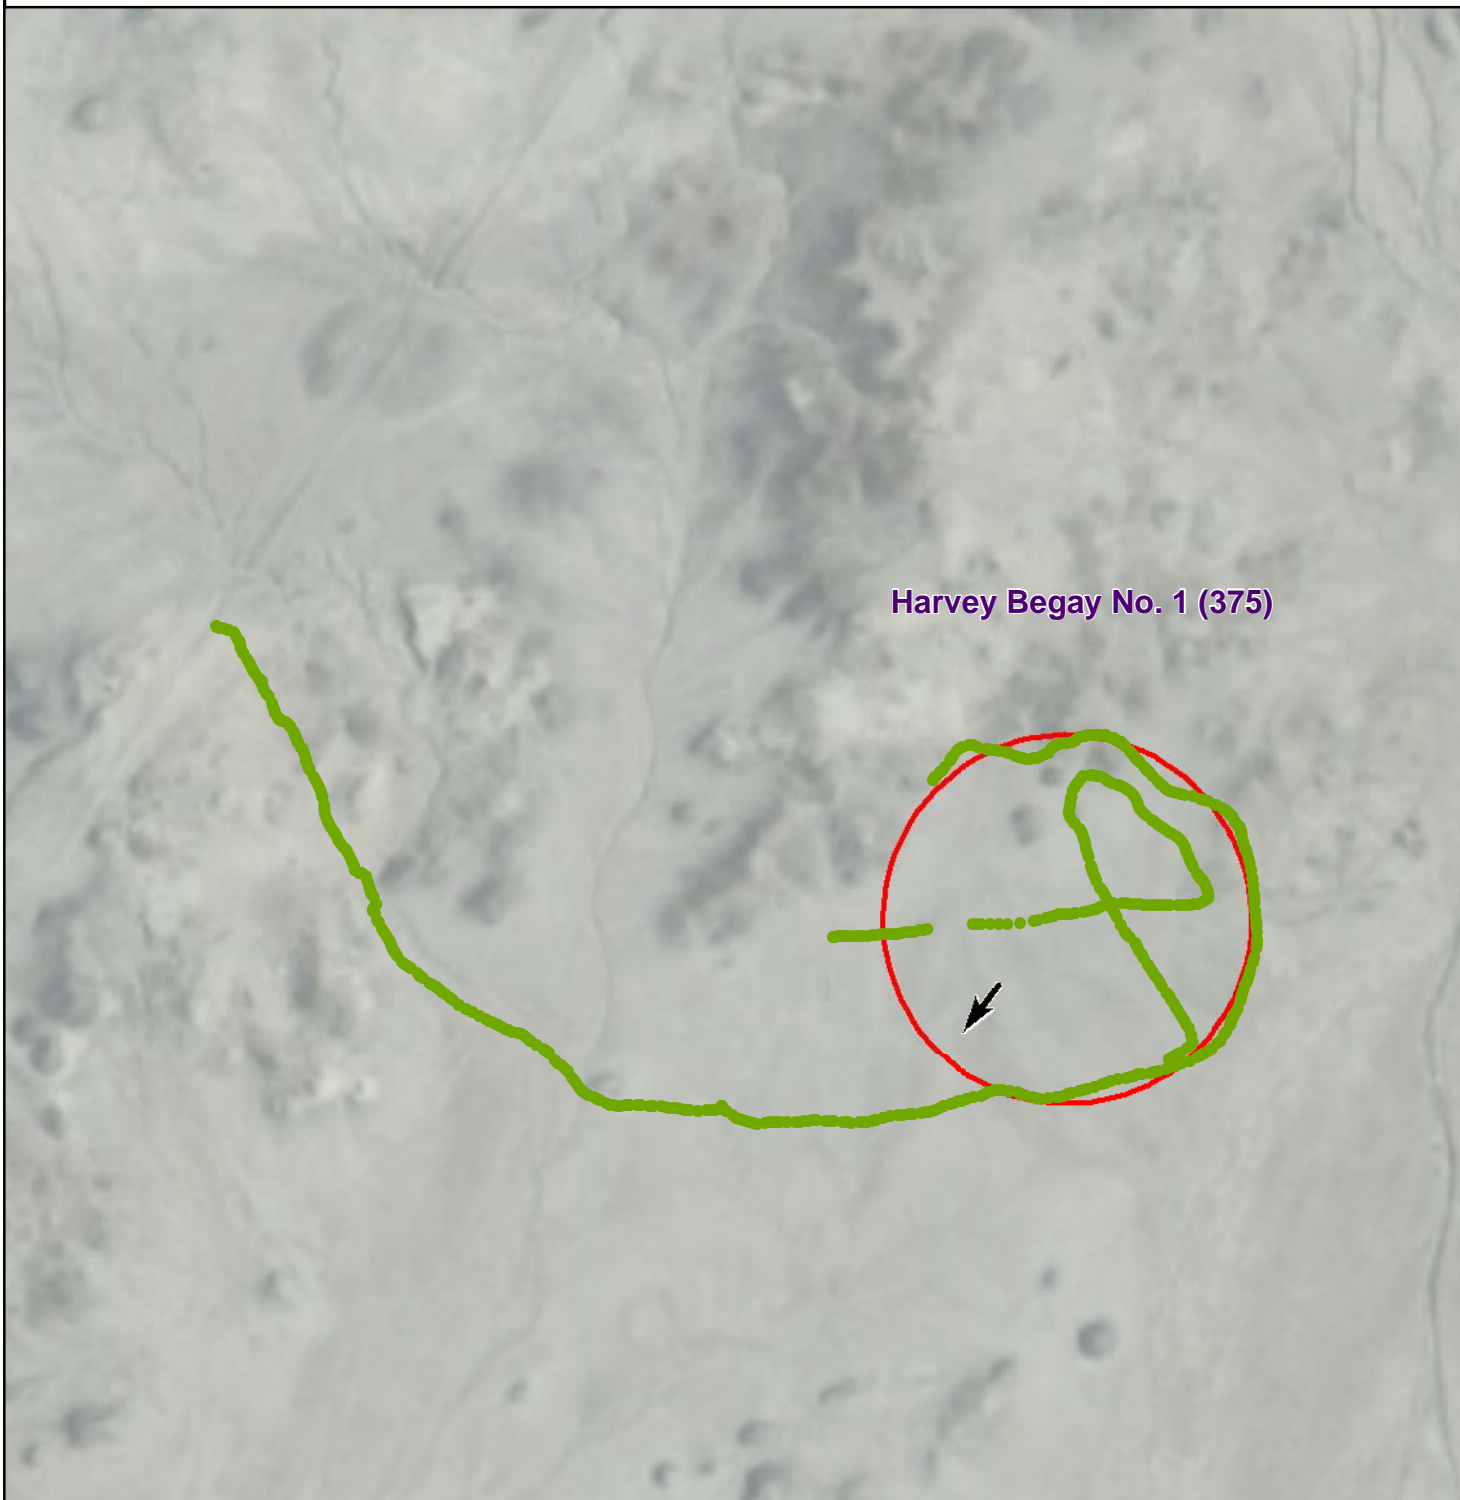
**Figure 1 - Gamma Radiation Measurements, Above Two Times Background  
Harvey Begay No. 1 (375)  
Coalmine Mesa Chapter, Navajo Nation**

**Highest gamma radiation measurement:** 21,224 counts per minute (cpm)

**Background Average:** 13,535 cpm      **Two Times Background:** 27,070 cpm

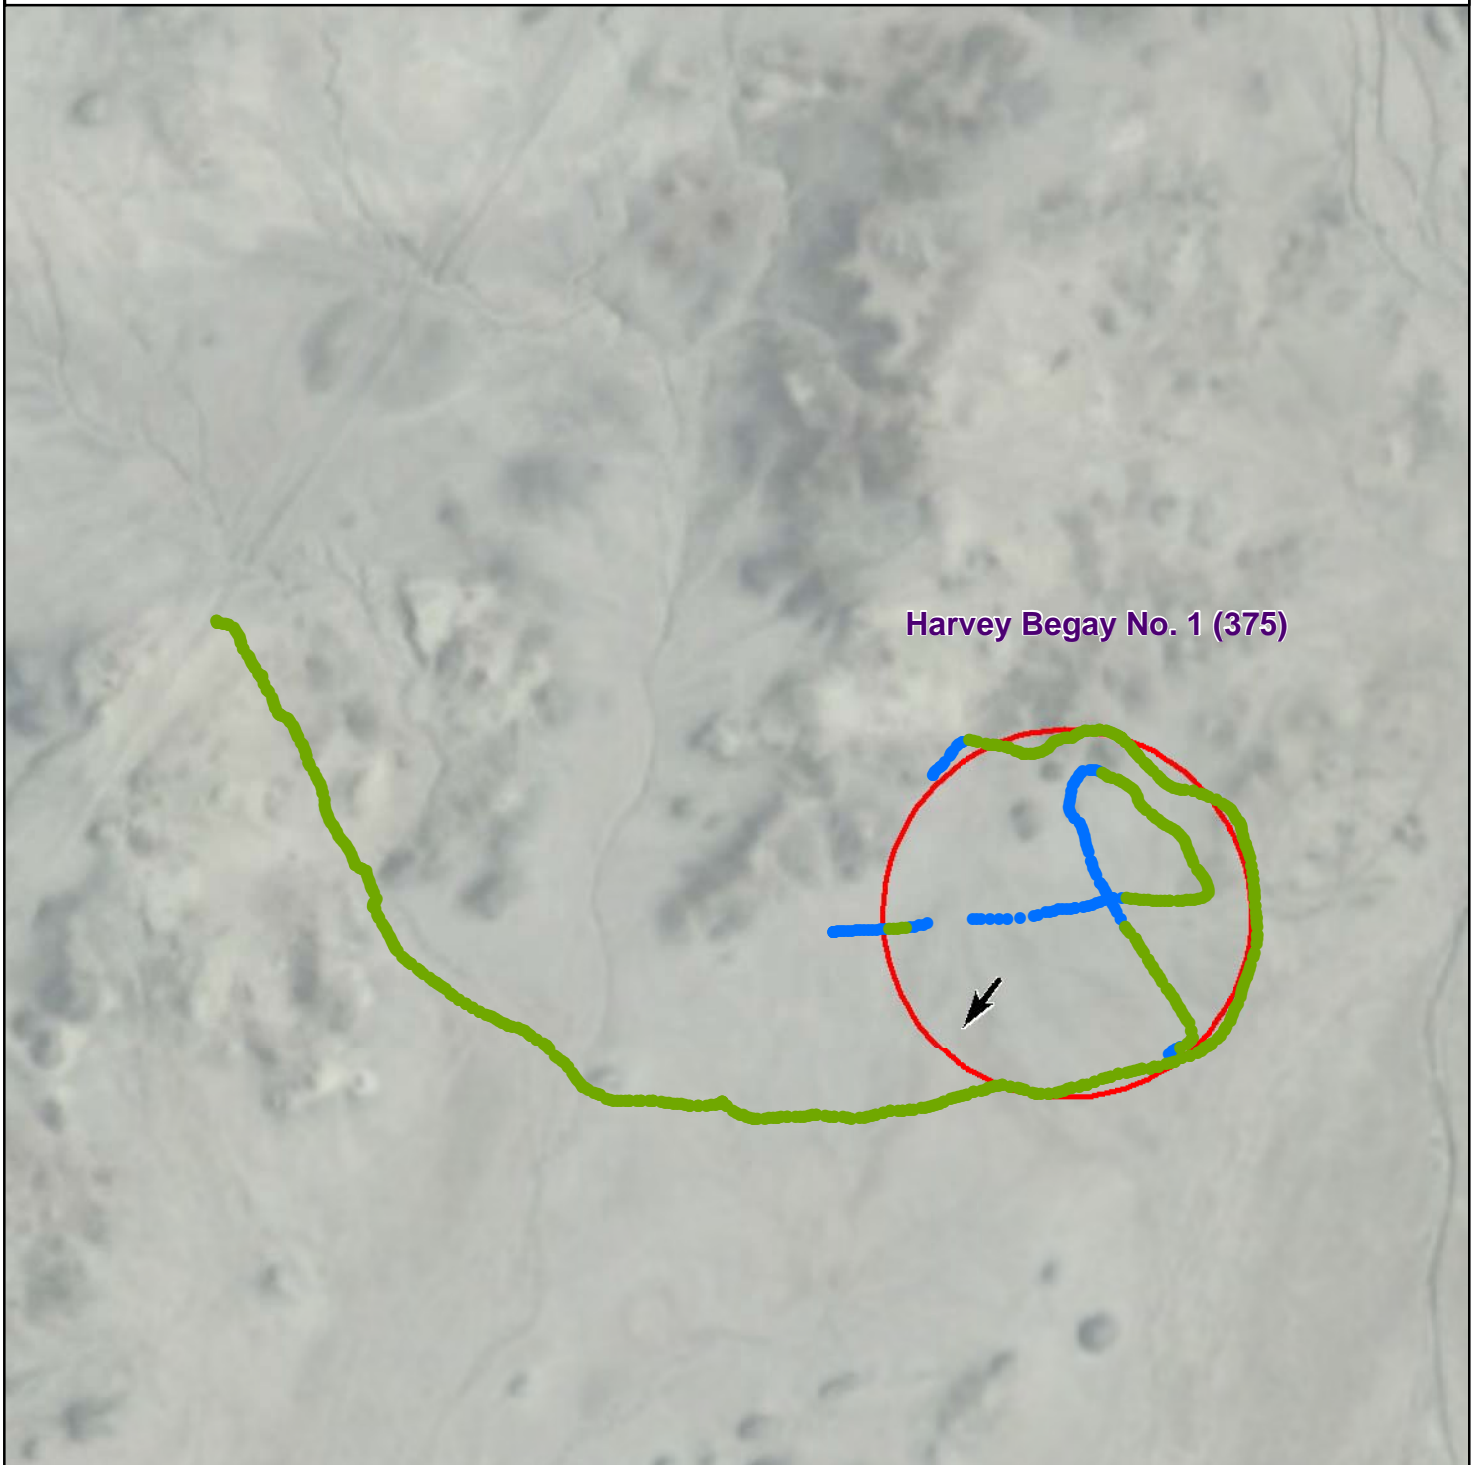
**Figure 2 - Gamma Radiation Measurements  
Harvey Begay No. 1 (375)  
Coalmine Mesa Chapter, Navajo Nation**

Measured as counts per minute (cpm) Average background 13,535 cpm
